Mortar deterioration of the masonry walls in historic buildings. A case history: Vanvitelli's Mole in Ancona

G. MORICONI

The utilization of data from advanced techniques, such as enhanced pattern treatment of x-ray diffraction analysis, combined with data from historical sources as well as environmental information, has been applied to diagnose the complex deterioration mechanism of a historic construction. A case history is provided dealing with a famous Italian construction in Ancona designed and erected by the Neapolitan architect Luigi Vanvitelli during 1733–1743, where both jointing and rendering mortars deteriorated very seriously. It has been found that the original lime–pozzolan mortar deteriorated due to physical events (rain water leaching, thermal changes, freezing–thawing, etc.), whereas Portland cement mortars, used to repair damaged walls, deteriorated by chemical sulfate attack.

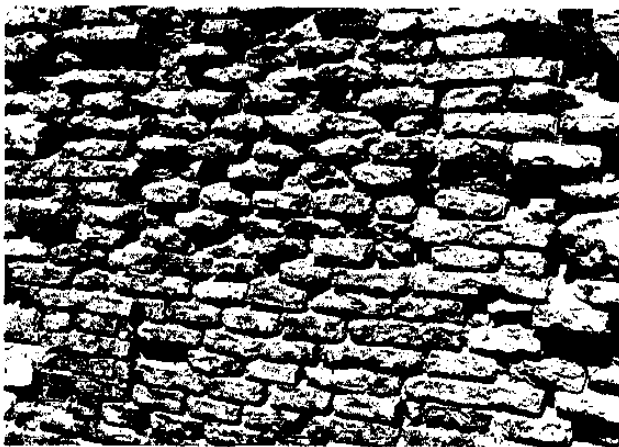
Because of the extensive state of deterioration of both the bricks (Fig. 2) and the mortar (Fig. 3) of the masonry walls, a survey specifically devoted to the materials used in the building has been carried out. The deterioration survey includes sampling the materials (bricks, mortars and efflorescences) for examination using chemical, mineralogical, physical, and mechanical tests. In addition to these laboratory tests, some *in situ* examinations, such as flat jacks, endoscopies and foundation inspection, have been carried out. Finally, all the results of these laboratory and *in situ* tests have been correlated with supplementary information concerning the environment, the climate, the history and the architecture of the building. In the present paper, for reasons of brevity, only the results concerning mortar deterioration will be examined.

Fig. 2 Deterioration of bricks and jointing mortars.

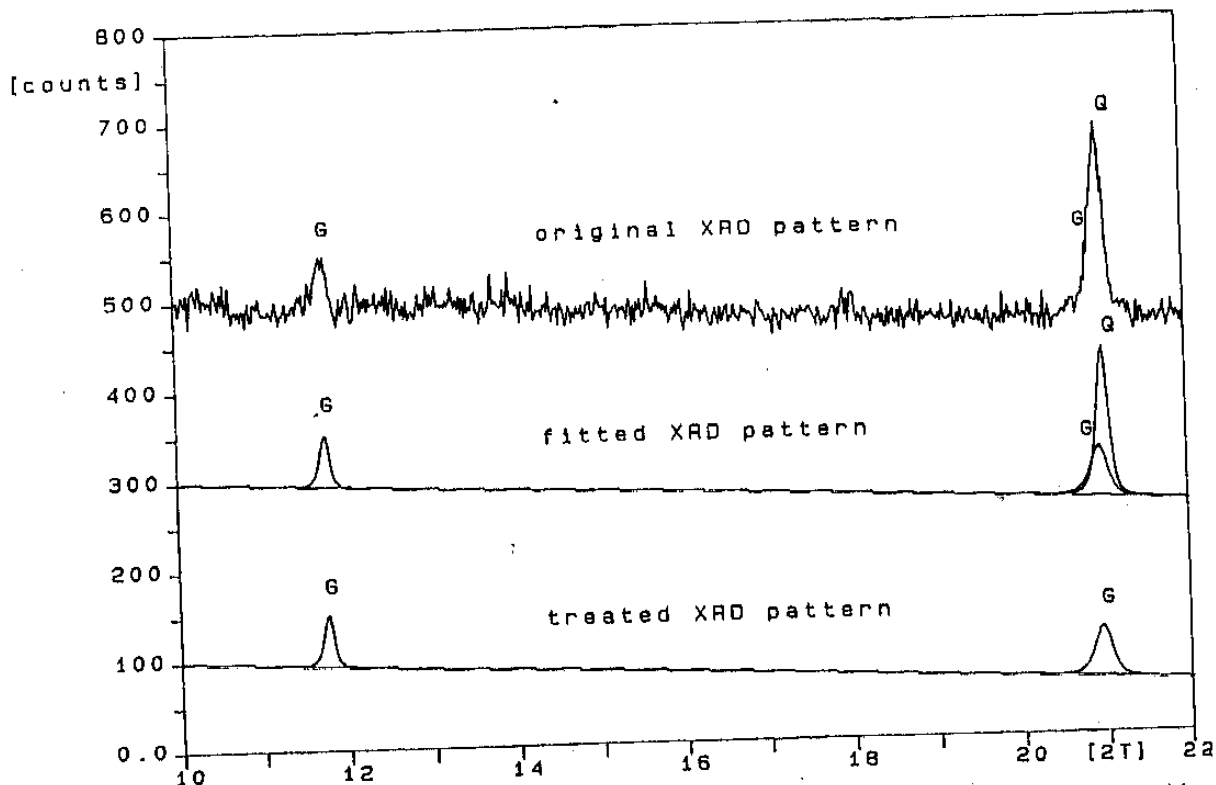
Fig. 4 XRD patterns (original, fitted and treated) of an interior jointing mortar with traces of gypsum (G) and large amounts of quartz (Q).

Indeed, through the 'profile fitting' technique the original XRD pattern can be treated in order to enhance very weak peaks belonging to products which may be present even in traces. For instance, Fig. 4 shows the original unmodified XRD pattern and the fitted one as well as the treated one of a lime-pozzolan mortar which contains large amounts of limestone-quartz based sand and only traces of gypsum.

Traces of gypsum (Fig. 4) as well as other sulfate salts have been detected by XRD. The amount of gypsum is so small that its presence cannot be ascribed to the utilization of a gypsum-based mortar. Therefore, gypsum must have been formed by water soluble sulfate salts, coming from bricks or sea water capillary rising and reacting with lime:

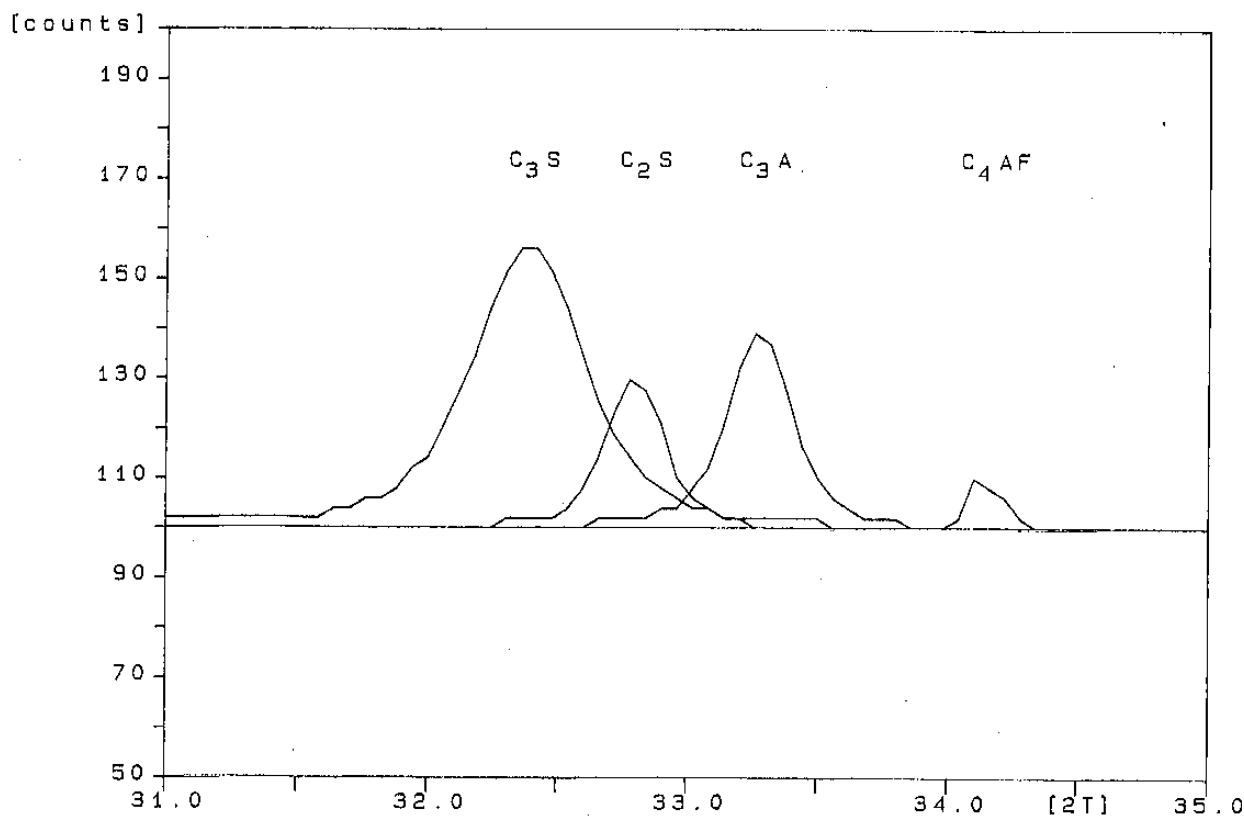
Facade jointing mortars have been examined as a potentially different material from the interior jointing mortar (Fig. 5), mainly because of different colour and/or appearance. The XRD analysis has confirmed this hypothesis. Indeed traces of C_3S , C_2S , C_3A and C_4AF ($\text{C} = \text{CaO}$, $\text{S} = \text{SiO}_2$, $\text{A} = \text{Al}_2\text{O}_3$) have been found (Fig. 6) in three available samples of facade jointing mortar. This means that some joints, for example like those of Fig. 2, have been repaired by filling the hollow outside space (20–30 mm) with a Portland cement mortar, clearly a long time (at least one century) after the original building construction (18th Century).

Fig. 6 Treated XRD pattern of a facade jointing mortar showing the presence of trace quantities of cement compounds.

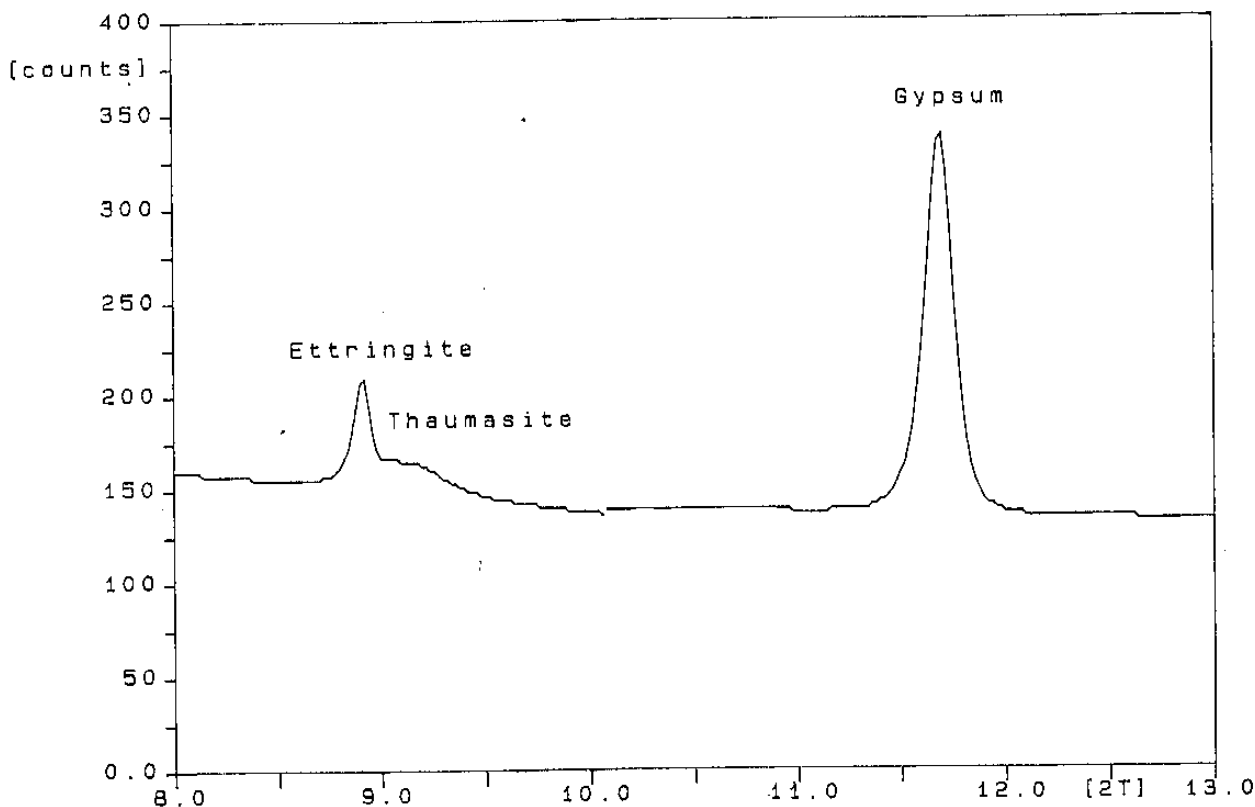
Moreover, detectable traces of ettringite and thaumasite, as well as a significant amount of gypsum, have been found in all the available samples of this repairing jointing mortar (Fig. 7). Gypsum production, and its subsequent transformation into ettringite ($\text{C}_3\text{A} \cdot 3\text{CaSO}_4 \cdot 32\text{H}_2\text{O}$) and thaumasite ($\text{CaSO}_4 \cdot \text{CaCO}_3 \cdot \text{CaSiO}_3 \cdot 15\text{H}_2\text{O}$):

Fig. 7 Treated XRD pattern of Portland cement based mortar sample to repair consumed facade jointing mortar.

could be ascribed to the formation process 2. Potential sulfate ion sources are (a) sulfate salts from bricks and (b) sea water capillary suction. In addition to these sources, gypsum could be formed by sulfur dioxide oxidation and subsequent sulfation of calcite [5–7], which is present both in the cement paste and in sand:

Therefore, in the repair mortar of Vanvitelli's Mole, all the three requirements for ettringite and thaumasite production [2] have been documented in the present work: (a) calcium aluminate or silicate hydrates produced by hydration of Portland cement used to repair the surface of jointing mortars; (b) gypsum formation by reaction of environmental SO_2 with lime; and (c) presence of water produced by sea water capillary suction or capillary condensation of water vapour in humid air.

crystallization, etc., appear to be responsible for the deterioration of this mortar. A Portland cement based mortar has been used in the past to repair the deteriorated jointing mortar as well as the rendering mortar. This repairing mortar appears to have been damaged by ettringite/thaumasite formation, as local humidity and sulfate sources are available to react with calcium aluminate/silicate hydrates produced by Portland cement hydration. Environmental SO_2 appears to be the main source of sulfate salts in addition to those coming from brick impurities or sea water capillary rise. For future repair work, cementitious materials should be tested and proved to be resistant to sulfate attack before their utilization in this historic building.

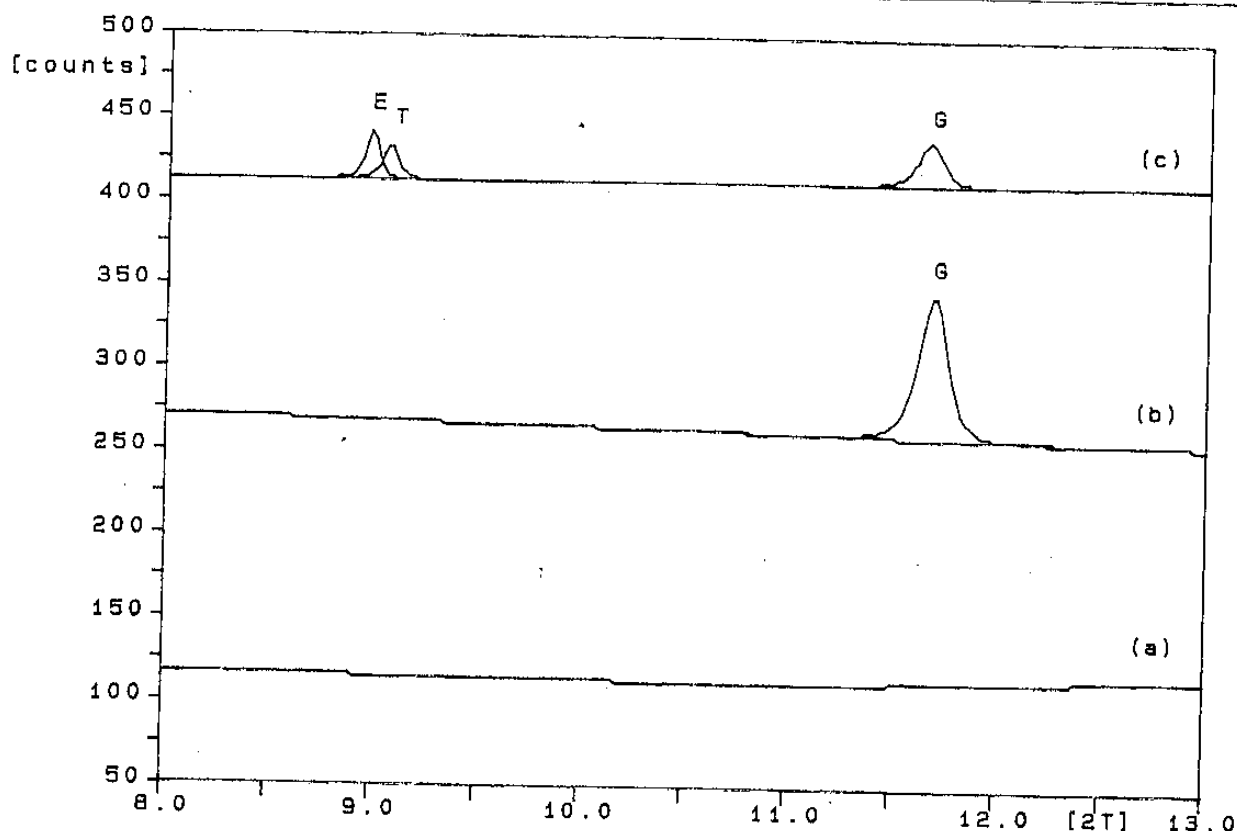
By XRD analysis, the five samples of rendering mortars have been separated into two types: (a) three samples based on lime-pozzolan mixes which do not contain any trace of gypsum, ettringite and thaumasite (Fig. 8a); and (b) two samples based on Portland cement mixes with traces of C_3S , C_2S , C_3A and C_4AF still present. In these

Fig. 8 Treated XRD patterns of three rendering mortars: A, without gypsum and ettringite or thaumasite; B, only gypsum (G); and C, gypsum (G), ettringite (E) and thaumasite (T).

two samples, two different situations have been found: in one sample a significant amount of gypsum is present without ettringite/thaumasite (Fig. 8b); in the other sample a significant amount of ettringite/thaumasite is present with a lower amount of gypsum (Fig. 8c). In the latter, it can be assumed that reactions 3 and 4 occurred, for some reasons, to a much higher extent than in the former: for instance, local humidity could have been higher in one area of the rendering mortar than in the other one, so that the degree of gypsum transformation into ettringite or thaumasite has been controlled by the local availability of water in the rendering mortar.
