## A case history of concrete degradation induced by an absorbing well

Jean-Marc Tulliani<sup>1</sup>, Laura Montanaro<sup>1</sup>, Alfredo Negro<sup>1</sup> and Mario Collepari<sup>2</sup>

**Abstract.** This case history concerns the severe degradation of concrete foundation plinths and piers of an about 35-year old building, imputable to sulphate attack promoted by sulphate-rich groundwaters. The presence of ettringite and thaumasite, near a significant amount of gypsum, was shown by X-ray diffraction analyses performed on ground concrete samples. Large gypsum crystals were mostly located at the interface between the cement paste and aggregates, as observed by scanning electron microscopy coupled to EDS microanalysis. An absorbing well located in the proximity of the building was recognized as the sulphate source. Consequences of this attack were a very poor bond-strength between cement paste and aggregates and a severe cracking of the concrete cover of the steel reinforcement.

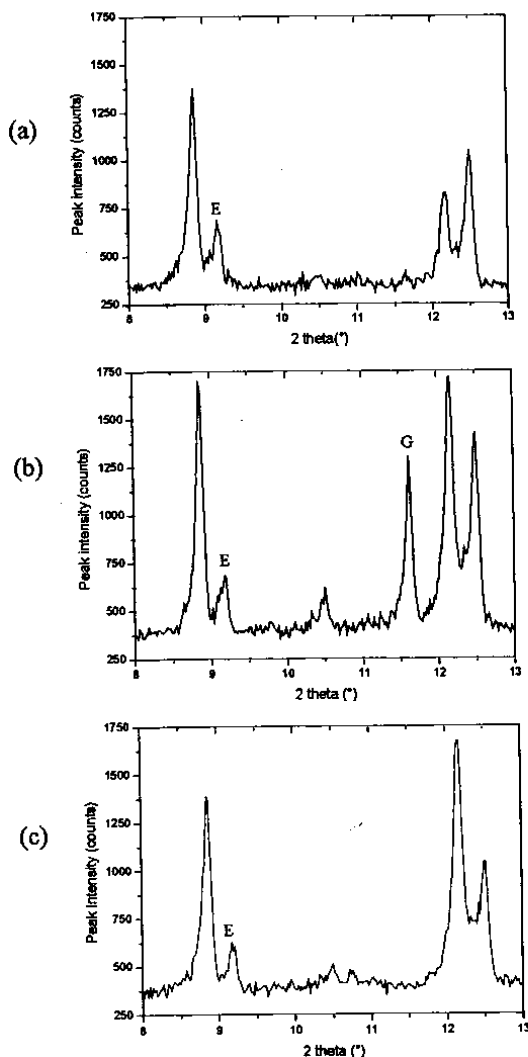
X-ray diffraction patterns of the samples collected from the above plinth and pier are reported in Fig. 1. Gypsum was clearly detected only in the sample at a height of 1m from the plinth. Small amounts of ettringite/thaumasite were present in the three samples collected from the plinth, and at a height of 1m and 3.5m respectively from the plinth.

Fig. 1. XRD patterns of degraded concrete samples: a) plinth sample; b) sample collected at a height of 1m from the plinth; c) sample collected at a height of 3.5m from the plinth (the peaks not indexed in the patterns are due to the aggregates; E = ettringite/thaumasite; G = gypsum)

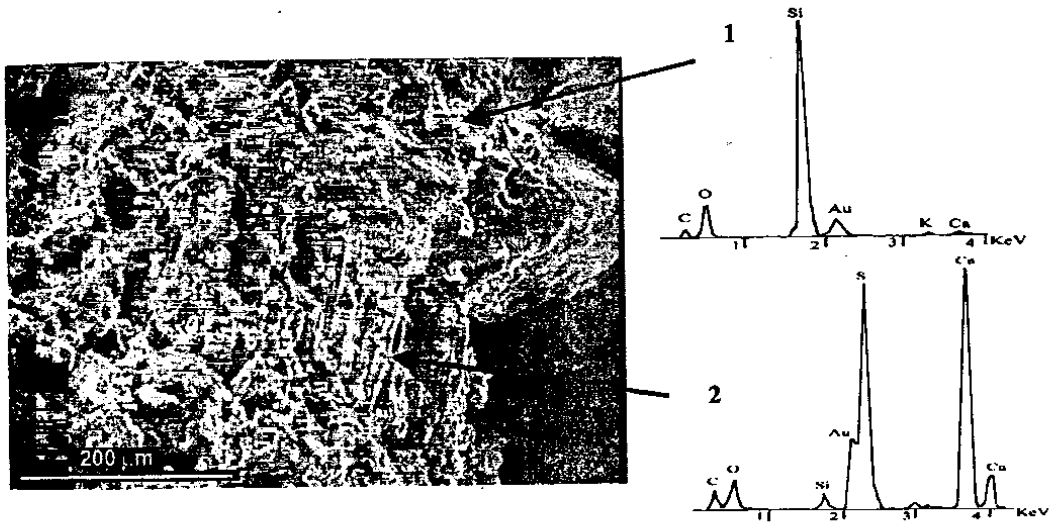
Fig.2. SEM micrograph of a degraded concrete sample collected at height of 1.0m from the plinth: point 1) quartz grain; point 2) gypsum crystals

A low-magnification image of the contact region between quartz aggregate and columnar gypsum crystals is shown in Fig.2: the phase compositions were identified by EDS analyses performed in the indicated regions. In many cases the growth of gypsum crystals at the interface between cement paste and aggregates (Fig.3) led to an almost complete detaching, which should be responsible of the significant strength decrease. Gypsum was only sometimes detected in the cement paste.

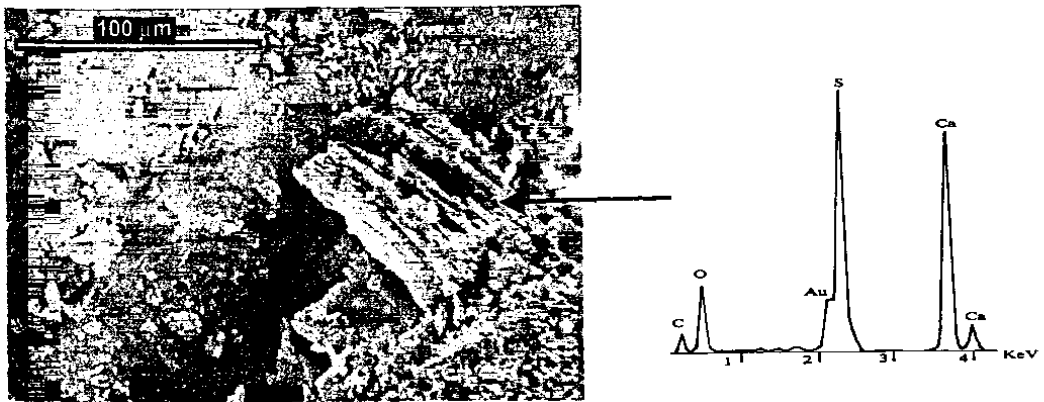
Fig.3. Detail of the contact zone between cement paste and quartz aggregate: gypsum crystals growing at this interface

The explanation that gypsum was mainly located at the interface between the cement paste and aggregate lies in microcracks originally present in the transition zone between the aggregate and the cement paste. These cracks are larger in width than most capillary cavities present in the cement paste matrix and therefore they can act in establishing interconnections, which increase the permeability of the system [2].
