Resistance to Sulfate Attack of Mixtures with Limestone-Portland Blended Cements

M. Collepari, S. Monosi, O. Favoni and J.J. Ogoumah Olagot

Synopsis: Blended binders based on limestone-Portland cements are very popular in Europe after the advent of the EN 197-1 European norm. However, according to some British researchers concretes with limestone-Portland blended cements would be more vulnerable to sulfate attack than the corresponding concretes with Portland cement when exposed to sulfate environment.

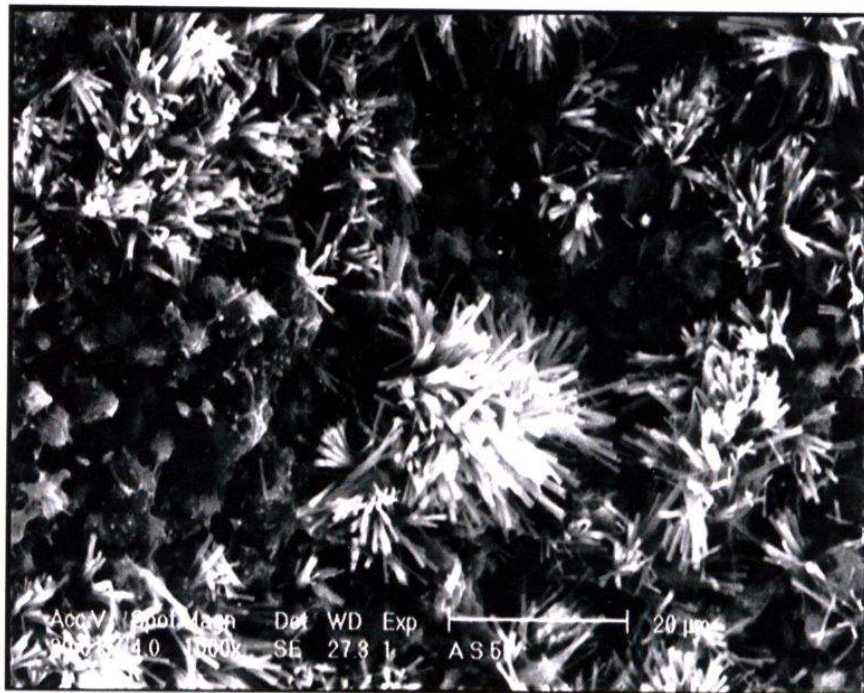
Figure 3 – Morphology of ettringite and/or thaumasite crystals grown into a crack formed by immersion in sulfate solution (2 days at 5°C) alternated with a drying period of 5 days at 40°C.

Only moderate damage in the specimens, limited to a surface layer about one millimetre deep, was recorded in the worst situation after 4 months of cyclic wet/dry exposure to sulfate at 5°C (Fig. 2). Figure 3 shows the typical morphology of ettringite fibrous crystals deposited into a crack of a pre-cracked specimen cured at 5°C and immersed in the Na₂SO₄ solution at 5°C. The chemical analysis by EDAX (Fig. 4) shows the presence of Ca, Al and S with traces of Si corresponding to a mixture of ettringite (C₃A·3CaSO₄·32H₂O) with minor amounts of thaumasite (CaCO₃·CaSiO₃·Ca SO₄·15H₂O) rather than to pure ettringite (3,4).
