## **Salt Weathering of Masonry Walls The Venice Experience**

By M. Collepardi, S. Collepardi and R. Troli

**Synopsis:** All the buildings in Venice insist on foundation immersed in sea water and then are permanently exposed to the capillary rise of salty water containing sodium, chloride and sulfate as main ions. Moreover, due to the closeness of the most important area of chemical industries in Italy, the buildings in Venice are also exposed to the effect of rainfalls containing sulfuric acid. Therefore, the materials of these buildings are between two very dangerous sources of attack one from the earth, the other from the sky, and both related, to some extent, to the action of salts. Capillary rise of sea water from the foundation produces two different types of distress. First, a chemical attack related to sulfate ions occurs, with formation of ettringite and/or thaumasite, which causes cracking and spalling of the rendering mortar. Second, a physical attack related to crystallization of salts (mainly NaCl) within bricks and mortars causes efflorescence and mainly subflorescence deteriorating effects. The prevention measures to avoid these distresses are based on chemical or

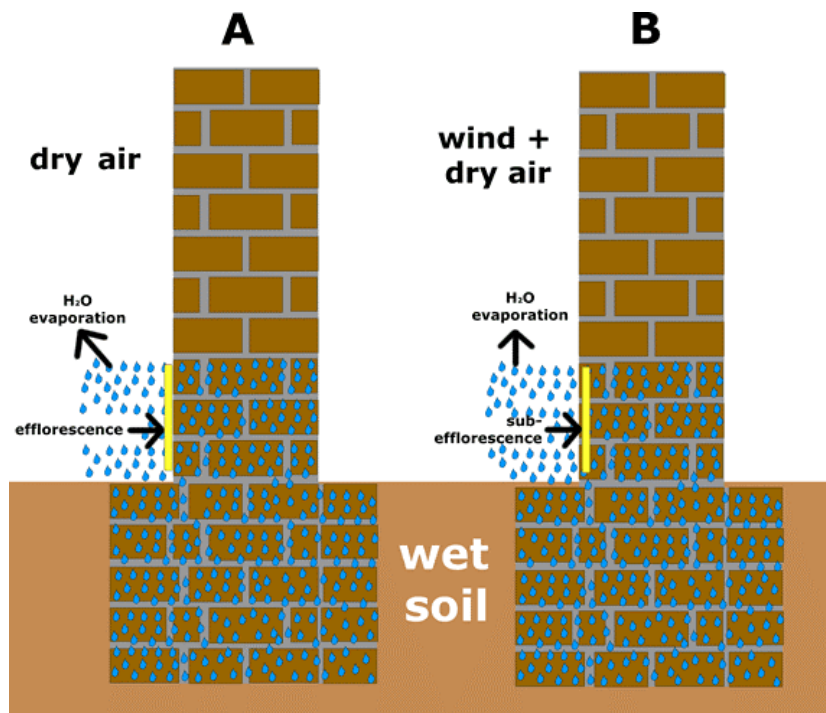
Fig. 1 – Efflorescence and sub-efflorescence in masonry walls embedded in wet soils and exposed to dry.

Figure 1 schematically shows two typical situations both related to the capillary rise of sea water in masonry walls, followed by drying in two different unsaturated environments: one occurs in a relatively dry and calm air with deposition of crystallized salt on the skin of the plaster (Fig. 1A); the other occurs in a drier and locally very windy air which accelerates the water evaporation even inside the wall under the skin so that the salt deposition occurs within the layer with subsequent detachment of the plaster (Fig. 1B): these two phenomena are known as “efflorescence” (Fig. 1A) and “sub-florescence” (Fig. 1/B) respectively.

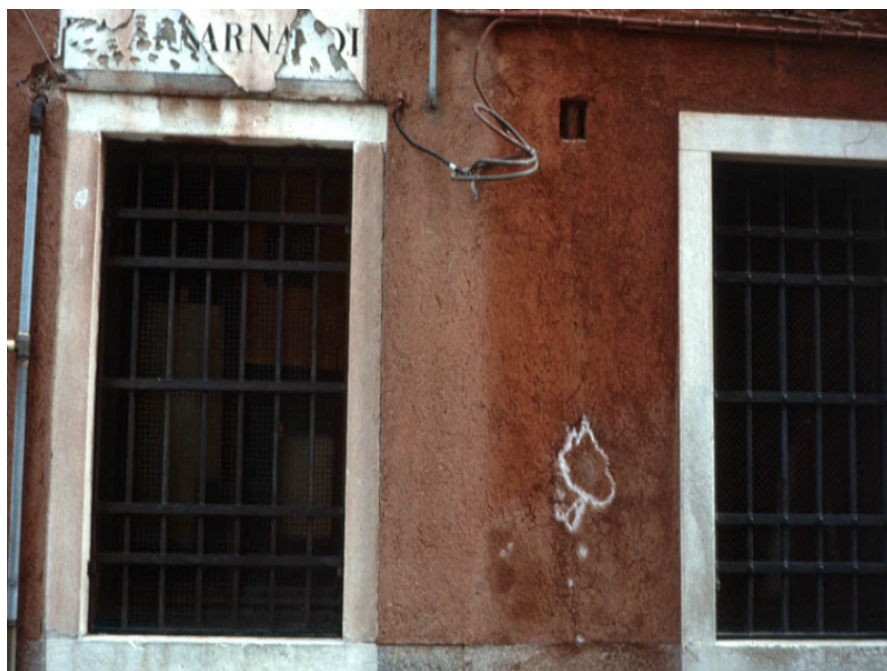
Fig. 2 – Typical efflorescence defect caused by NaCl crystallization on the masonry wall in Venice.

Figure 2 shows a typical efflorescence defect with deteriorating effect for the aesthetics of the surface of the wall but without any serious damage for the mechanical consistency, of the plaster. Chemical and XRD analysis indicate that NaCl is the prevalent component of the white stain with minor amounts of other salts. Sometimes the efflorescent stain disappears after a strong and prolonged rain due to the great water solubility of the salts present in the efflorescence. If these salts come from sea water, the efflorescence appears again some time after the rain. If the efflorescence disappears definitely after one or more rainy events, then it means that the salts on the surface of the wall – generally based on sodium sulfate – were caused by some source such as sulfate-contaminated bricks, which is exhausted after some wetting-drying cycles related to rainy and sunny days.

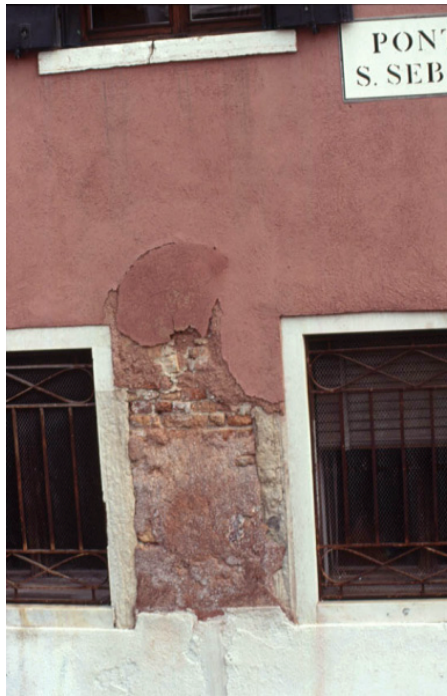
Fig. 3 – Typical subflorescence damage due to the detachment of the rendering mortar.

Figure 3 shows a typical subflorescence defect with a more serious damaging effect which causes cracking and detachment of the red-colored lime-pozzolan\* mortar for the out pushing pressure produced by the crystallization of NaCl just under the mortar itself.

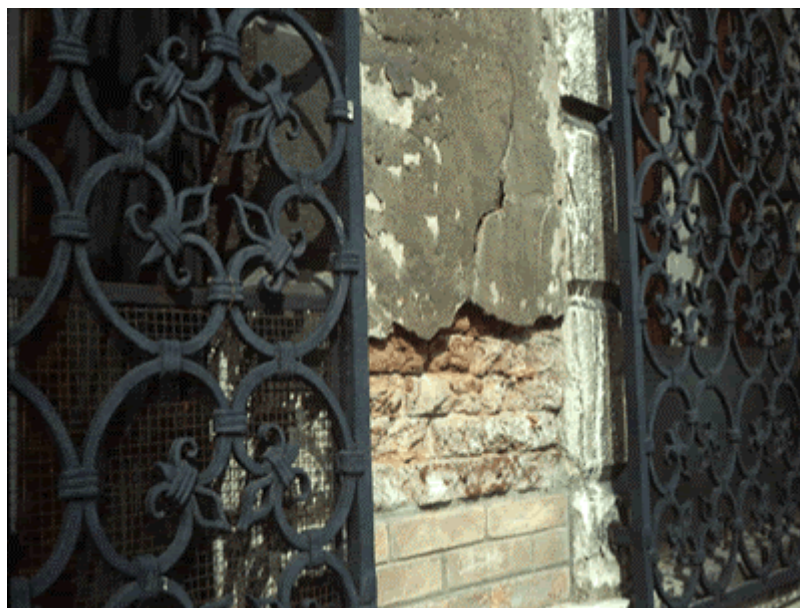
Fig. 4 – Detachment of a cementitious rendering mortar due to ettringite formation according to equation [1] for the presence of  $\text{SO}_4^{=}$  in the bricks of the masonry wall.

The above illustrated defects, both based on physical events related to capillary rise and water evaporation, not always appear so distinctly since other potential distresses, related to chemical mechanisms, can also occur. In the case shown in Fig. 4 the expansion, caused by the ettringite formation, was responsible for the detachment of the cement rendering mortar. The sulfate needed for the ettringite formation was present as impurity in the bricks and reacted with  $\text{Ca}(\text{OH})_2$  and the C-A-H phase of the cement rendering mortar.

On the other hand, the damaging effect shown in Fig. 4 cannot be related to some physical effects such as those shown in Figures 2-3: as a matter of fact the sea water capillary rise and the potential crystallization of NaCl were-excluded due to the “cutting” of the wall followed by the “insertion” of an impermeable barrier (a lead-plate in the past time or a plastic more flexible sheeting according to the modern technique). This barrier against the sea water capillary rise very popular since the past time in the historic buildings of the Republic of Venice.

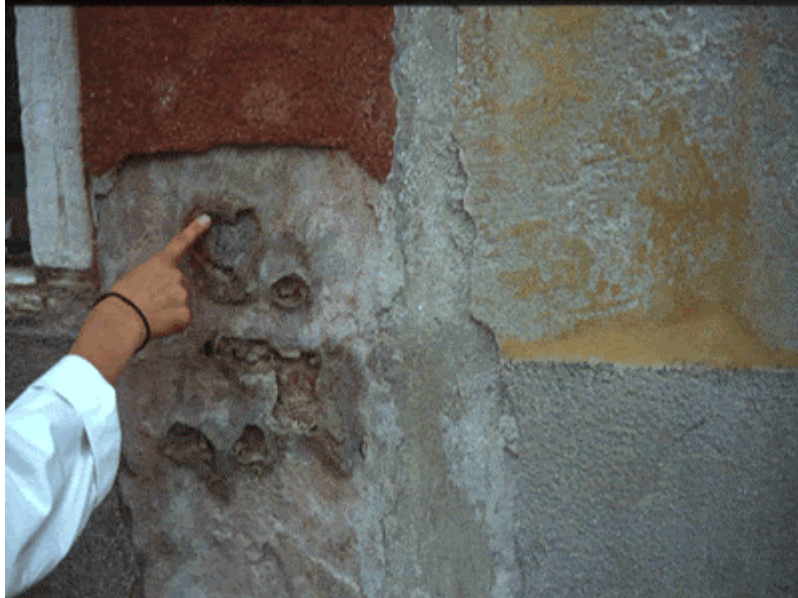
Fig. 5 – Severe damage of the rendering mortar (on the left) due to NaCl crystallization and thaumasite formation according to equation [2], both caused by capillary rise of sea water in Venice. No damage in the wall on the right for the barrier against capillary rise.

Figure 5 shows two adjacent buildings: that on the right does not show any damaging effect because it was dried according to the above “cutting-inserting” technique and so sea water couldn’t rise along the wall; the cementitious rendering mortar of the building on the left hand was severely damaged for two overlapping mechanisms: the physical effect due to the NaCl crystallization and the chemical one producing a destroying effect, related to the thaumasite formation due to the presence of sulfate in the bricks and the C-A-H, C-S-H,  $\text{CaCO}_3$  of the cementitious mortar\*:

Through the XRD analysis, the presence of sulfate was detected in the bricks of the two adjacent buildings of Fig. 5; however in the dry building on the right, neither the thaumasite formation according to the reaction [2], nor the NaCl crystallization, due to the sea water capillary rise, could occur for the absence of any barrier against the capillary rise of sea water.

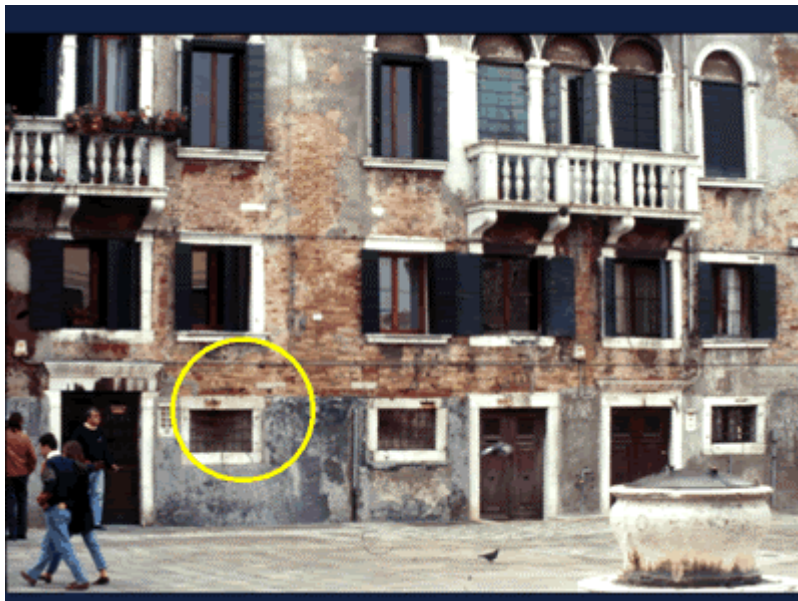
Fig. 6 – Cementitious mortar on the wall of a building in Venice to protect it from the sea water during the high tide.

The last example of deterioration, related again to a complex mechanism, is that presented in Fig. 6 which shows a thick and impermeable cementitious mortar (about 2m high from the ground level) attached to the wall of a historic building to protect it from the penetration of sea water of the high tide.

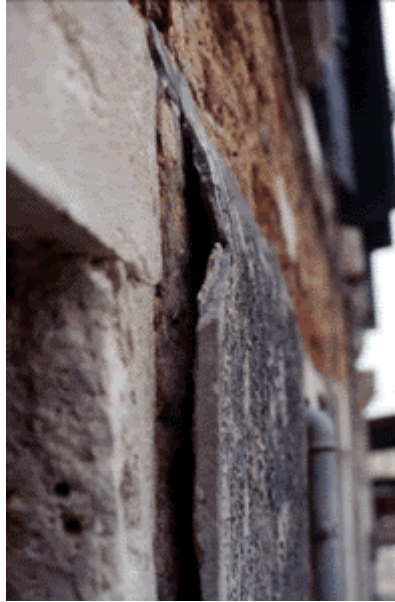
Fig. 7 – The mortar shown in Fig. 6 completely detached from the wall due to restrained expansion related to swelling and NaCl crystallization.

The wall was permanently wet for about 2m high from the ground level due to the sea water capillary rise, whereas the cement mortar became saturated in the occasion of the first high tide. Then, due to the swelling, there was a restrained expansion of the mortar due to the bond to the wall, which caused the bending of the mortar (Fig. 7). However, some crystallization of NaCl, found in the space between wall and mortar, could contribute to the detachment of the rendering mortar from the wall.
