Concrete Sulfate Attack in a Sulfate-Free Environment

by M. Collepardi

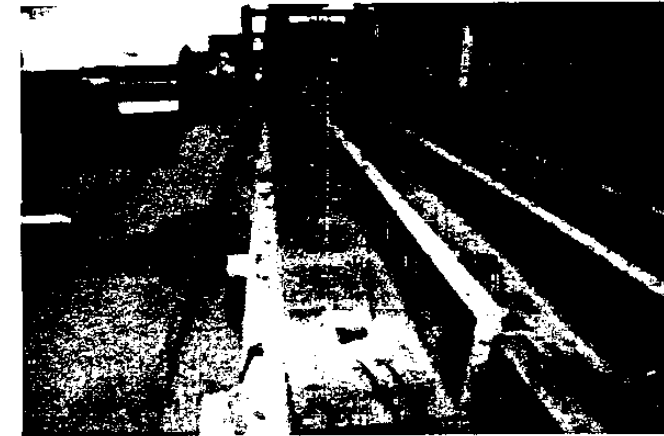
Fig. 1—Parallel formworks of concrete ties in the long line method.

Field observations of microcracks of un-used concrete ties revealed that their presence was related with the specific type of manufacturing process, and in particular with the local stress level induced in the concrete by the sudden cutting of the prestressing strands. Two typical processes are adopted for manufacturing prestressed concrete ties. In one of these - named *long-line method* (Fig. 1) and widely used all over the world - the same set of prestressing strands is used for 15 to 20 lined up concrete ties. Each concrete batch is in general placed in a row of 6 or 8 parallel ties. When the concrete attains adequate compressive strength, the prestressing strands are cut. At this time **excessive local stress can occur in the concrete area close to one end of the tie**, especially in the eight ties located at the two extreme parallel rows.

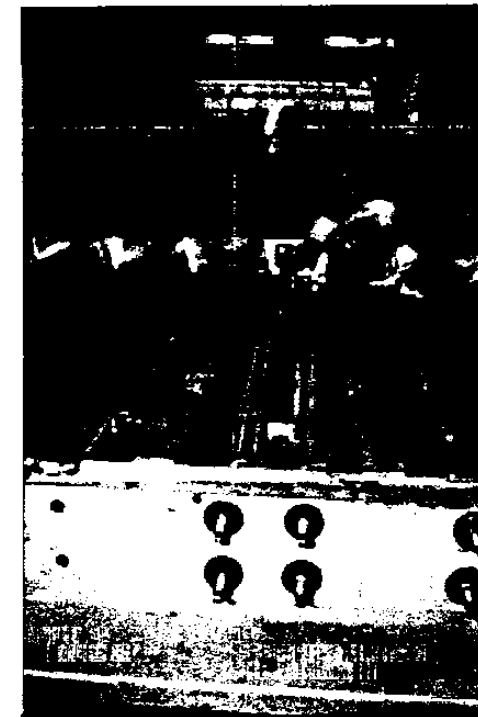
Fig. 2—Formwork of concrete tie in the anchored steel plate method.

In the other process - named *anchored steel-plate method* (Fig. 2) - each concrete tie is individually prestressed using reinforcing wires anchored to steel plates by special cold-worked heads. The anchored steel plates, embedded in the concrete mixture at the ends of each tie, transfer the prestressed force from the wires to the concrete when this reaches adequate compressive strength. This process consumes more time and also workmanship, and therefore prestressed concrete ties processed according to this method are more expensive. However, as a matter of fact, in concrete ties manufactured with this process microcracks do not appear or occur to less extent at the time of prestressing, and the frequency occurrence of the *DEF*-induced damage seems to be lower than in concrete ties manufactured with the *long-line method*.

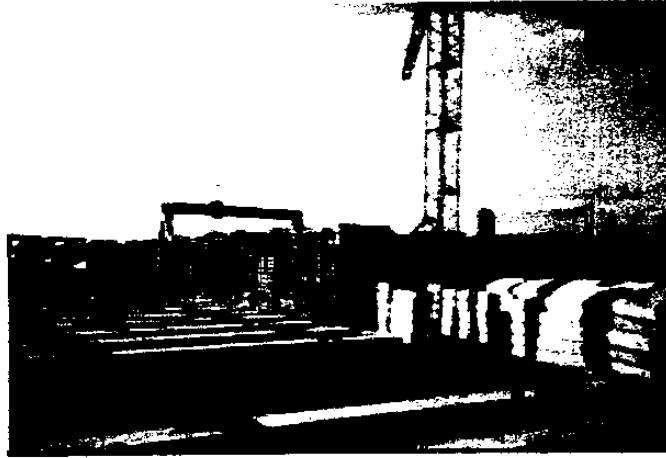
Fig. 3—Unused stockpiled concrete ties exposed to different micro-environment (sun and shadow, dry and rain).

The role played by the micro-climate (Fig. 3) was studied by examining unused, two-year old, stock-piled concrete ties, all microcracked as evidenced by the field optical microscope. Those exposed to the alternate actions of rain and sun (on the sides and specially at the tops of outdoor storage stacks) were severely macrocracked and *DEF*-damaged; those exposed to rain but in a permanent shadow condition evidenced a less severe distress; concrete ties permanently protected from both rain and sun exposure (below and in the middle of stacks) remained only microcracked without any further crack growth and apparent *DEF*-related damage.

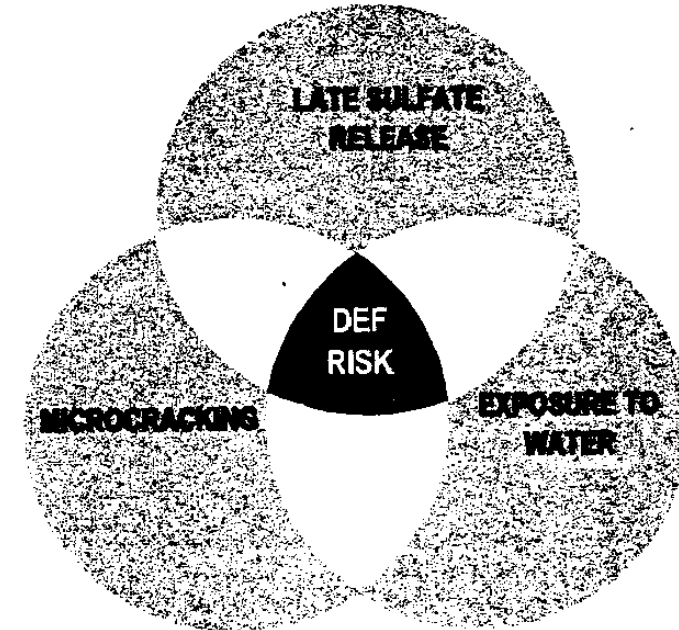
Fig. 5—Holistic model showing delayed ettringite formation damage as a function of late sulfate release, microcracking, and exposure to water.

Each event, in turn, can be determined by one or more possible causes which will be considered in detail further on. First, a synthetic representation of the holistic approach for the *DEF*-related damage will be examined through the help of Fig. 5 where each event corresponds to a circle. The area in the middle of the triangle corresponds to situations of serious risk for *DEF*-related deterioration since all the three needed elements of the system are present: **late sulfate release** caused by cement with high sulfate content (especially that with high content of clinker sulfate in less available form) can feed the delayed deposition of ettringite in the **pre-existing microcracks** after diffusing through the pore solution in concrete **exposed to environmental water**. In the absence either intermittently or continuously of one of these elements, *DEF* cannot occur and this explains the erratic character of this phenomenon.
