DEF-Related Expansion of Concrete as a Function of Sulfate Content in the Clinker Phase or Cement and Curing Temperature

By M. Collepardi, J.J. Ogoumah Olagot, D. Salvioni and D. Sorrentino

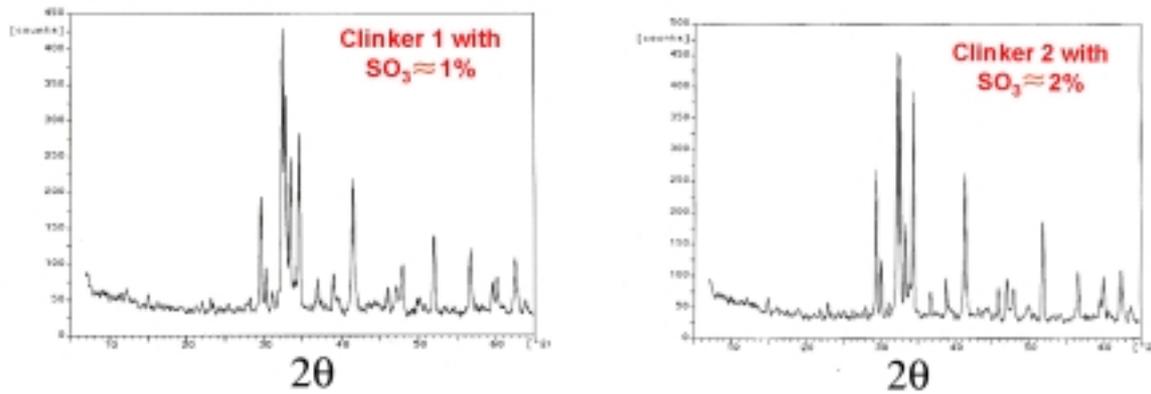
Fig. 1 – XRD patterns of the two clinker with the SO₃ content of about 1% and 2%.

Clinker and cements: Two clinkers were used with approximately the same mineralogical composition in terms of XRD patterns (Fig. 1). The main difference being the sulphate content: 1.05% in clinker 1 and 2.15% in clinker 2 (Table 2), both percentages in terms of SO_3 .

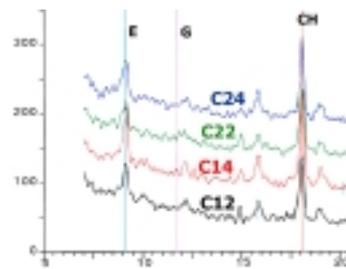
Anhydrous cements

T_{max}=20°C – Time = 24 hrs

T_{max}=80°C – Time = 24 hrs

Fig. 2 – XRD patterns of anhydrous or hydrated cements at 24 hrs cured at 20°C or steam-cured at 80°C: G=gypsum; CH=Calcium hydroxide; E=Ettringite; M=Monosulfate.

On the basis of preliminary tests of steam-curing, it was found that for the cements shown in Table 3, the critical temperature causing the thermal decomposition of ettringite and its transformation into monosulfate ($\text{C}_3\text{A} \cdot 3\overline{\text{C}}\overline{\text{S}} \cdot \text{H}_{12}$) was 80°C [11]. Figure 2 shows the XRD patterns of the four anhydrous cements and of the corresponding hydrated products at 1 day

Moreover, the expansion is exacerbated by the higher sulphate content in the clinker phase (*C24C* $>$ *C14C*; *C24S* $>$ *C14S*). All these results could be related to the disappearance of ettringite caused by the steam-curing process at relatively high temperatures ($> 80^\circ\text{C}$) as shown by the cement paste experiments (Fig. 2) and on its subsequent reformation at *later ages* (*DEF*) when kept under water.

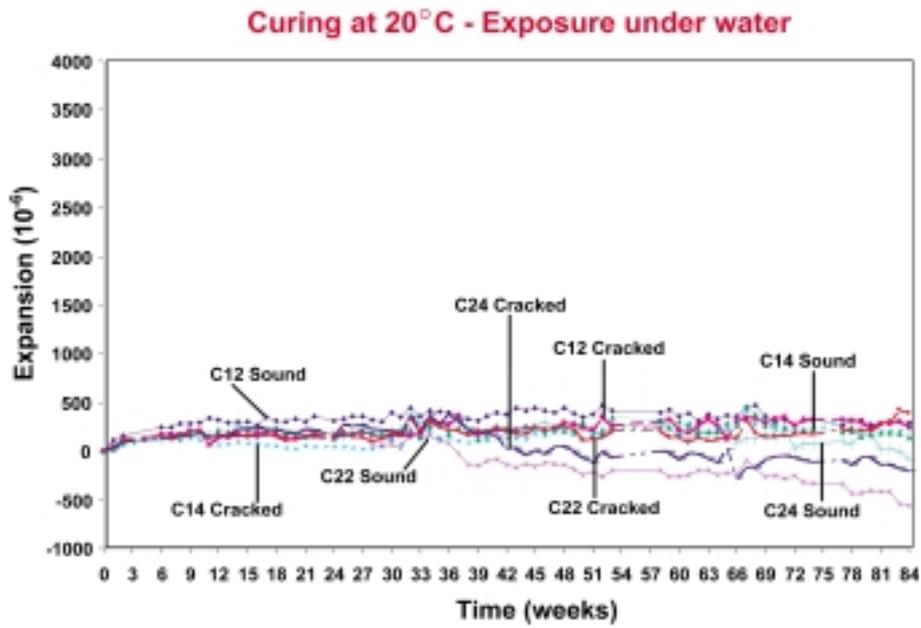
Fig. 3 – Change length of concrete specimens cured at 20°C and then permanently submerged under water.

There is no significant expansion in concrete specimens cured at 20°C (Fig. 3) independently of the pre-existing cracks or the SO_3 content in portland cement (2.60-4.20%) and in the clinker phase (1.02-2.15%); the expansion of about $200-300 \cdot 10^{-6}$ after some months of permanent immersion under water is normal and can be related to the swelling effect of the cement paste under water [18].

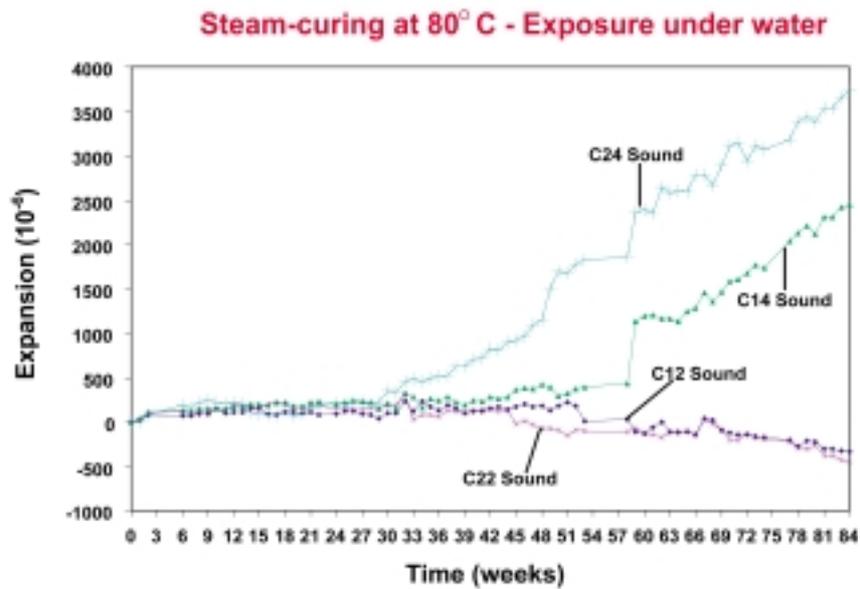
Fig. 4 - Change length of sound concrete specimens cured at 80°C and then permanently submerged under water.

On the other hand, when concretes are steam-cured at temperature as high as 80°C (Fig. 4) there is a significant expansion ($\approx 1500 \cdot 10^{-6}$ in less than 1 year) for the sound specimens *C24S* immersed under water.

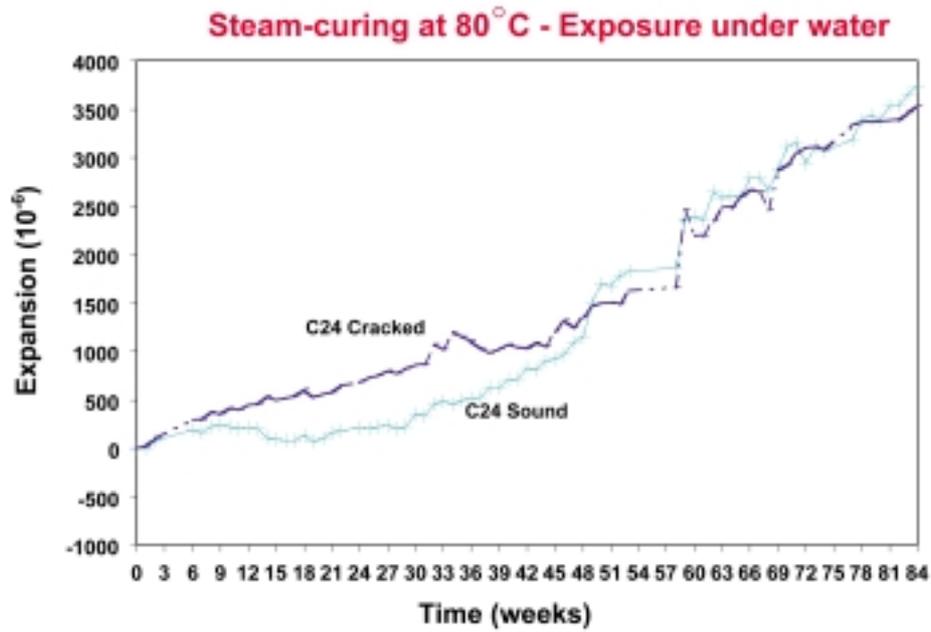
Fig. 5 - Change length of cracked and sound specimen cured at 80°C and then permanently submerged under water.

The expansion is higher and quick in the concrete specimens with pre-existing cracks, *C24C* and *C14C* than in the corresponding crack-free specimens, *C24S* and *C14S*, (Fig. 5 and 6).

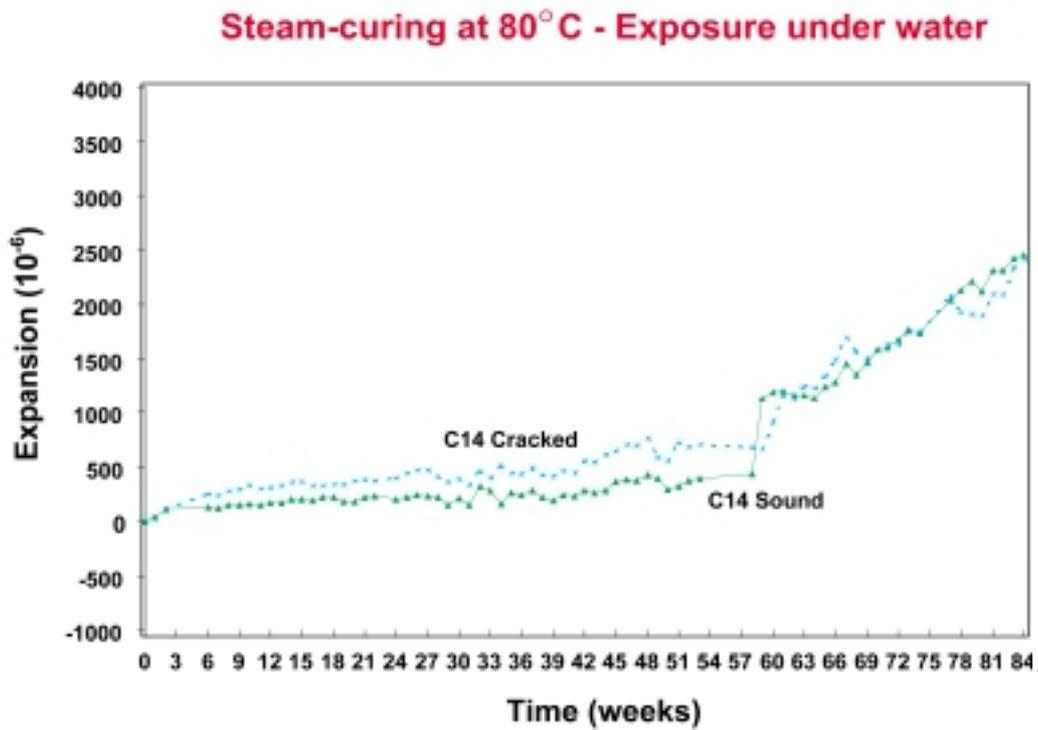
Fig. 6 - Change length of cracked and sound specimen cured at 80°C and then permanently submerged under water.

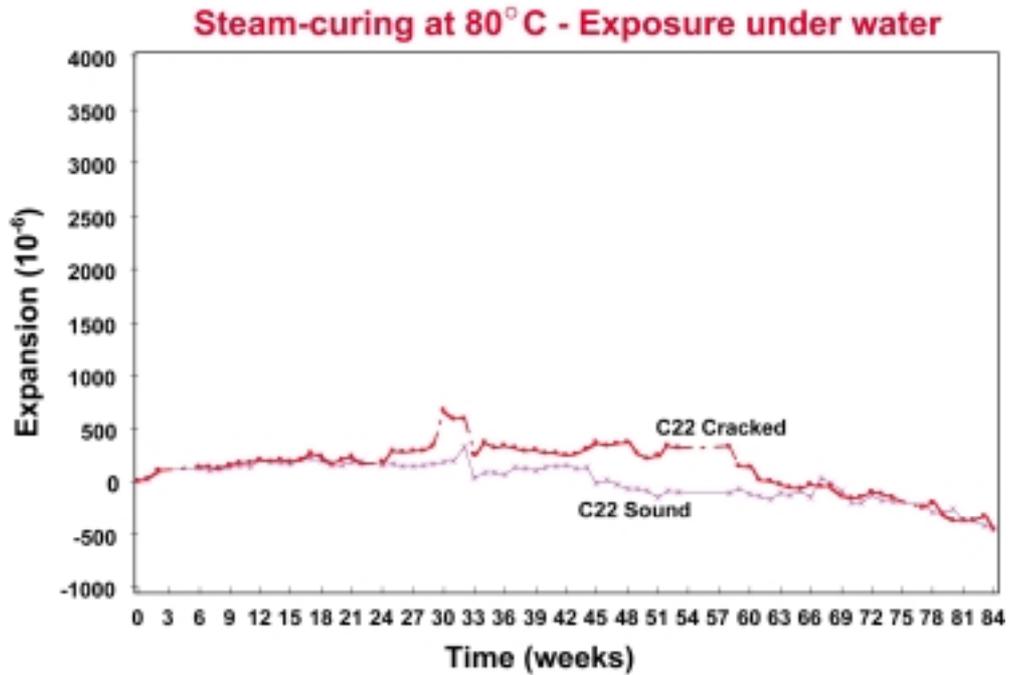
Fig. 7 - Change length of cracked and sound specimen cured at 80°C and permanently submerged under water.

No significant length change was recorded for both sound and cracked steam-cured specimens when a relatively low sulfate content ($< 2.70\%$) was adopted in the cement (Fig. 7 and 8).

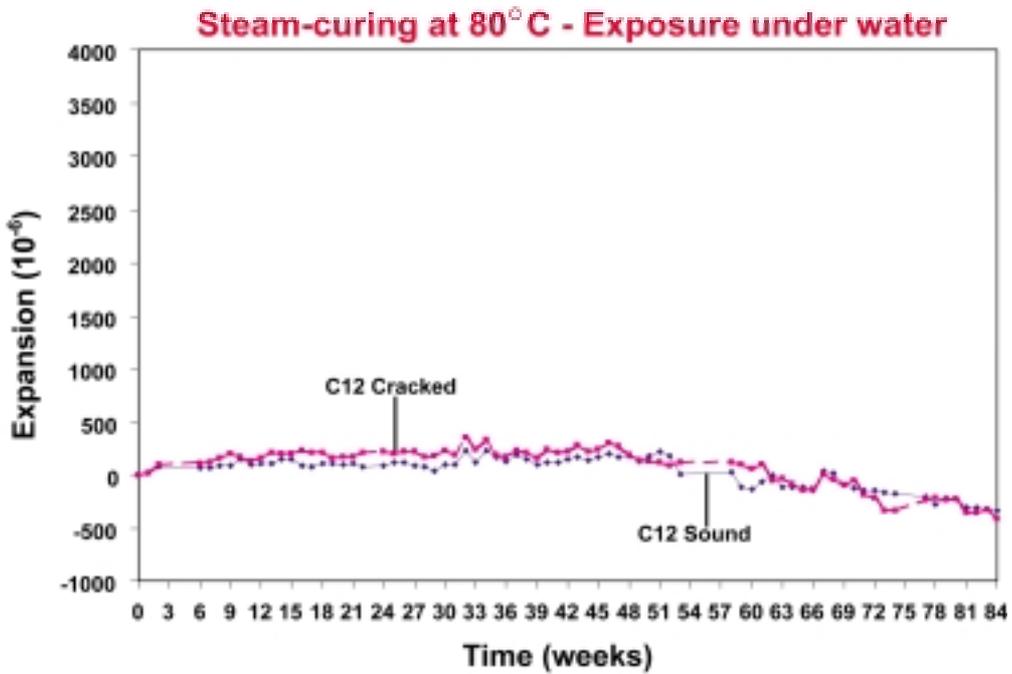
Fig. 8 - Change length of cracked and sound specimen cured at 80°C and permanently submerged under water.

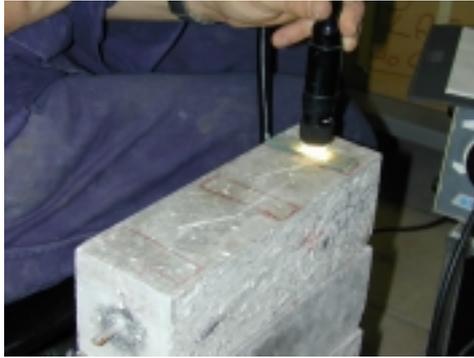
Fig. 9 – Observation of the width-crack by optical microscope.

In order to confirm this hypothesis concrete specimens were observed by optical microscope in order to assess the width change of the pre-existing cracks (Fig. 9) or the appearance of new microcracks on the surface of the originally sound specimens. The white material filling the pre-existing cracks (Fig. 10) or depositing within microcracks of the originally sound specimens (Fig. 11) was analyzed by X-Ray Diffraction (XRD) analysis. The XRD patterns (Fig. 12) indicate that ettringite (E), beside calcium hydroxide (CH), are the main products filling the pre-existing cracks or within the new microcracks of the originally sound specimens.

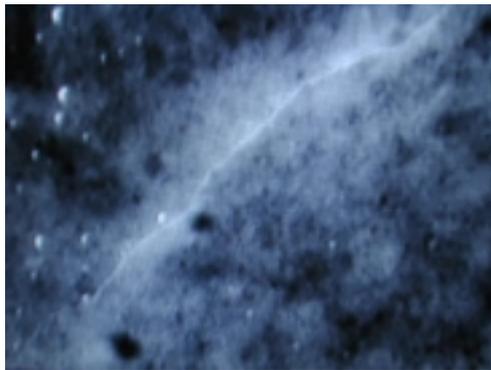
Fig. 10 – White material filling the pre-existing cracks.

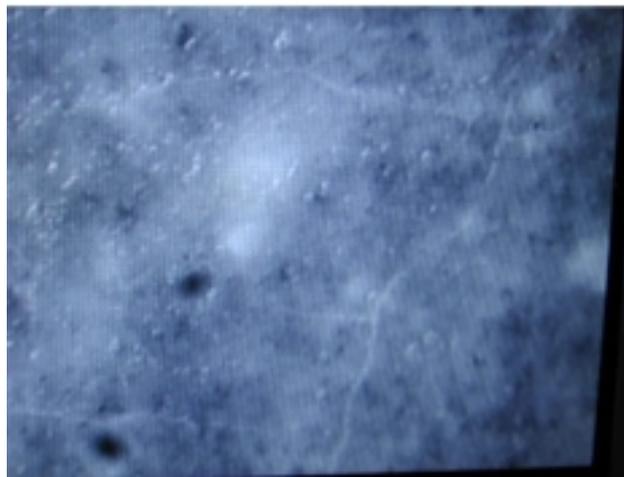
Fig. 11 – White material filling the microcracks of the originally sound concrete specimens.

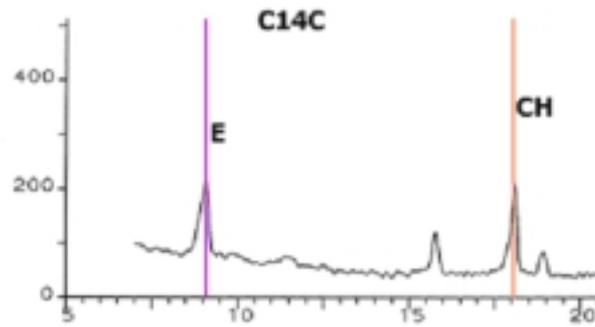
Fig. 11 – Typical XRD pattern of the white material filling the pre-existing cracks of the C14C concrete specimens.

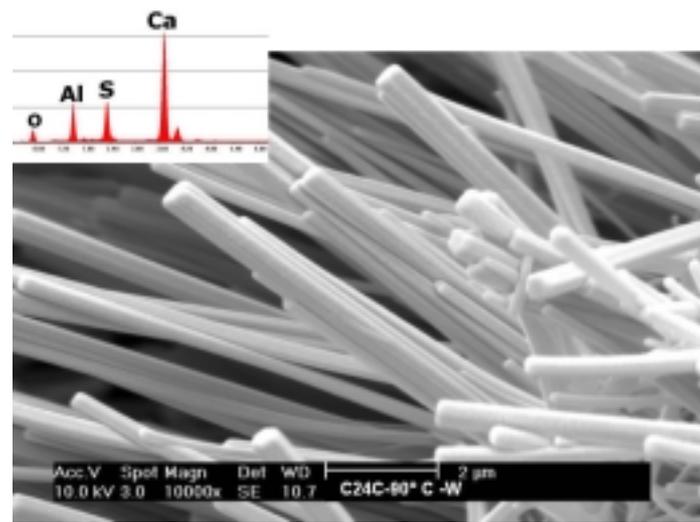
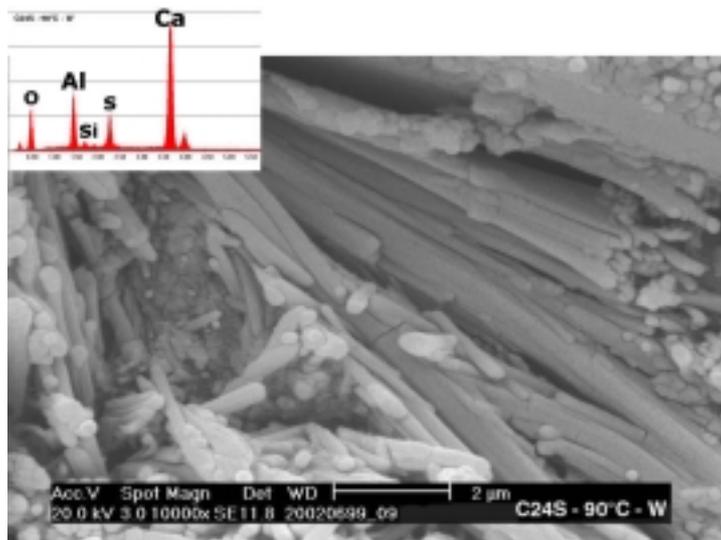
Fig. 14 – SEM/SED of ettringite deposited into the pre-existing cracks (above) and within the new microcracks (below).

The SEM/EDS results of the material filling the pre-existing cracks or the new microcracks are shown in Fig. 13. The main difference in the morphology is in the better growth of the ettringite fibers filling the pre-existing cracks of the *C24C* specimen, with respect to the stubby ettringite crystals mixed with some C-S-H filling the new microcracks formed in the originally sound specimen (*C24S*).

4. SEM and EDS studies combined with XRD analysis indicated the formation of well crystallized ettringite fibers (20 μm long and 0.5 μm thick) deposited into the pre-existing cracks or the new micro-cracks formed during the exposure to moist environment.
