Mortar deterioration of the masonry walls in historic buildings. A case history: Vanvitelli's Mole in Ancona

G. MORICONI

The utilization of data from advanced techniques, such as enhanced pattern treatment of x-ray diffraction analysis, combined with data from historical sources as well as environmental information, has been applied to diagnose the complex deterioration mechanism of a historic construction. A case history is provided dealing with a famous Italian construction in Ancona designed and erected by the Neapolitan architect Luigi Vanvitelli during 1733–1743, where both jointing and rendering mortars deteriorated very seriously. It has been found that the original lime–pozzolan mortar deteriorated due to physical events (rain water leaching, thermal changes, freezing–thawing, etc.), whereas Portland cement mortars, used to repair damaged walls, deteriorated by chemical sulfate attack.

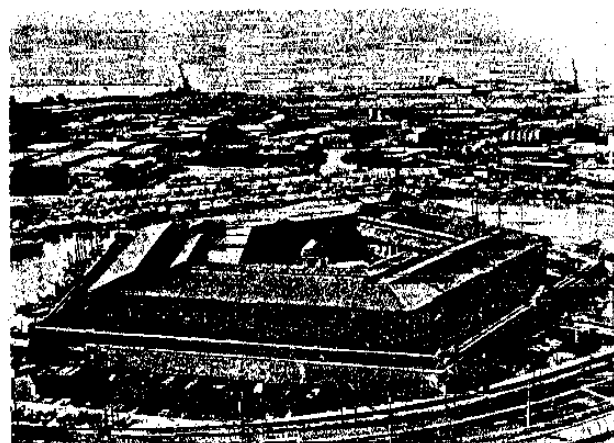
Fig. 1 A general view of Vanvitelli's Mole in Ancona, Italy.

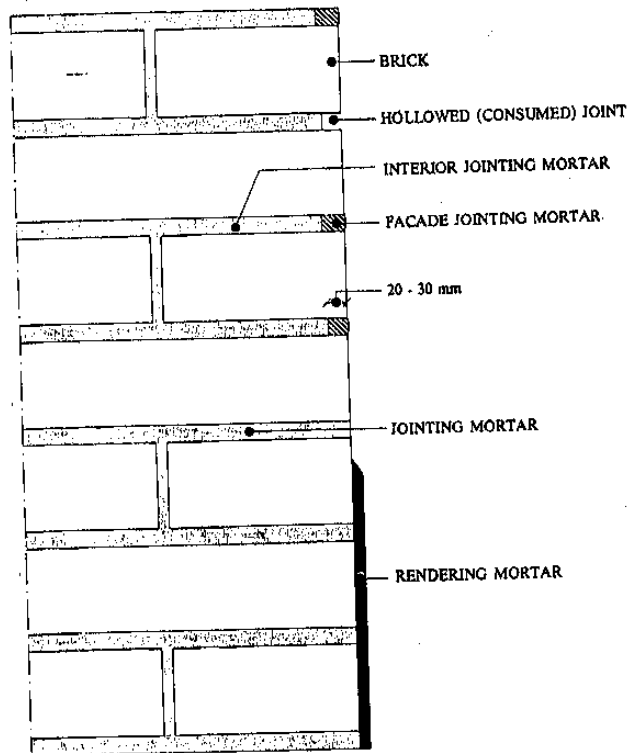
The mortar samples examined in the present paper belong to three different types, schematically represented in Fig. 5: (i) interior jointing mortars (9 samples); (ii) facade jointing mortars (3 samples); and (iii) rendering mortars (5 samples). Consequently, the results are dealt with in three sections.

Fig. 5 Schematic representation of the brick masonry wall (cross-section) to illustrate the terminology.
